Rogue River Organics

Sample 150-022525-578

Cream Filling

Sample Submitted: 02-25-2025; Report Date: 03-03-2025

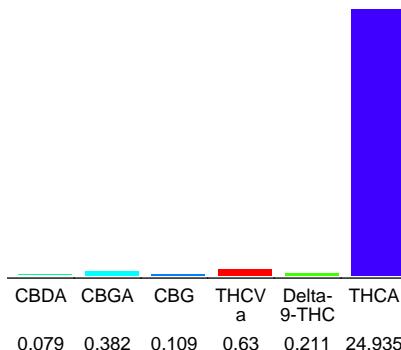
### Cannabinoid Profile

Cannabinoid	% wt	mg/g
CBDA	0.079	0.79
CBGA	0.382	3.82
CBG	0.109	1.09
THCVa	0.63	6.3
Delta-9-THC	0.211	2.11
THCA	24.94	249.35
<b>Total Cannabinoids</b>	<b>26.35</b>	<b>263.5</b>
<b>Calculated Total THC</b>	<b>22.08</b>	<b>220.79</b>
<b>Calculated CBD Yield</b>	<b>0.07</b>	<b>0.69</b>
